**SAS Superstructure**

Daily Diary Report by Bid Item

Diary #: 298 Const Calendar Day: 977 Date: 12-May-2012 Saturday

**04-0120F4
04-SF-80-13.2/13.9
Self-Anchored
Suspension Bridge****Weather**

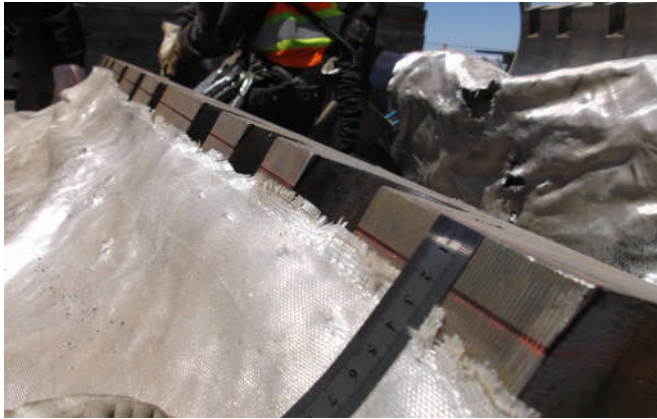
inspection. They are having some issues with wires bunching, & pushing down into the gap between CB halves in the bottom groove. The solution was to add a small chamfer (20mm long by 5mm deep) along the bottom of the CB as approved in RFI-1190. See attached photo.

Layout lines for chamfering bottom of Cable Band (20mm X 5mm chamfer per RFI-1190)
